CASE STUDY

#40

6 inch well flowline

ENGINEERED COMPOSITE SOLUTIONS

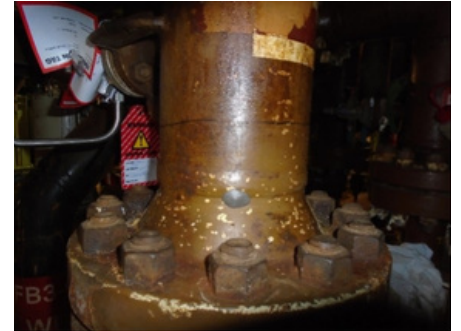
A 6 inch well flowline was suffering from internal corrosion resulting in a small through wall defect close to a flange, which forced the client to shutdown the installation. It was proposed to use a FutureWrap composite repair to reinstate the pipework strength and provide a long term seal.

Initial condition of pipework

The design of the FutureWrap repair was according to ISO 24817. The design approach was to strengthen and locally seal the leak. The assumed defect size was circular of diameter 25 mm. The design parameters were: internal pressure 50 bar, temperature 900C, design lifetime 2 years. The repair design resulted in a thickness of 12.2 mm (15 layers) of FutureWrap Glass/LT composite repair with an axial length of 250 mm.

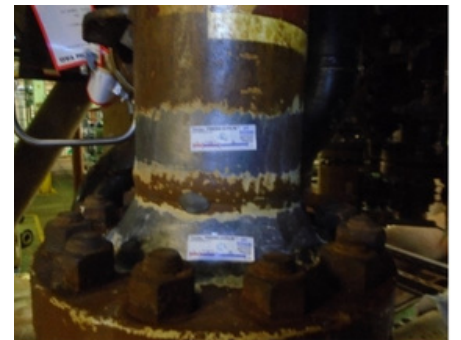
After surface preparation

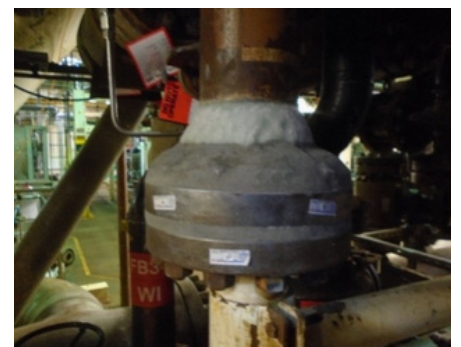
After profiling

The installation steps are shown in the photographs from surface preparation through to final curing. Due to the geometry, a limited landing area was required, this was factored into the design. This was successfully executed by ECS technicians, using ECS specialist filler putties, to plug the pin hole and then encapsulate the flange within the FutureWrap repair, which consisted of 15 layers of the FutureWrap Glass/LT repair. Full QA/QC measurements were made to demonstrate that the FutureWrap repair was applied in accordance with ISO 24817.

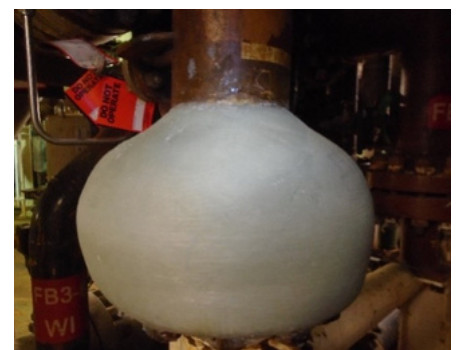
Final cured repair

Due to the offshore installation being shut down, FutureWrap materials and ECS technicians mobilised within 24 hrs. The 6 inch well flowline was suffering internal corrosion was repaired using a FutureWrap Glass/LT composite repair with a design life of 2 years.
